Poe Engineering, Inc.

February 7, 2019

Re: 8473 Stone Wood Cove E, Cordova, TN 38018

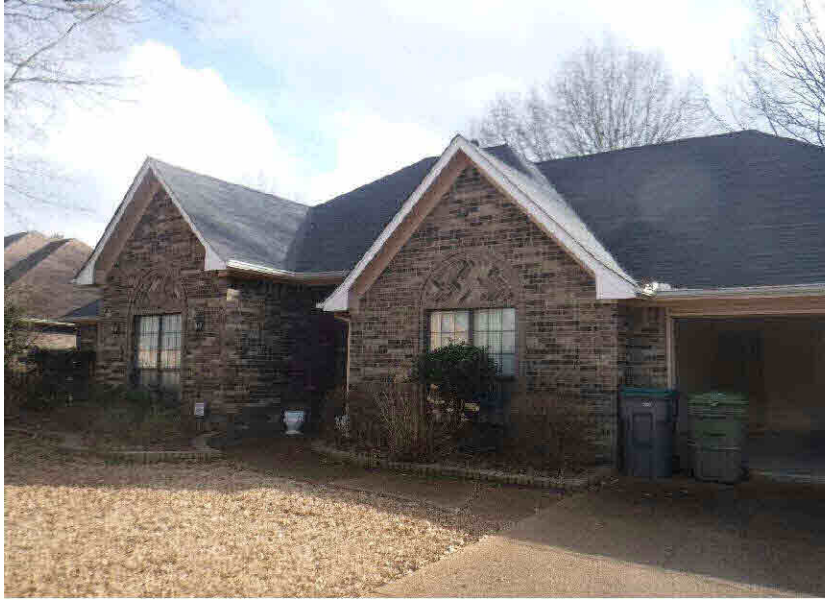
Photo 1

The single-story residence with brick veneer is supported on a monolithic “slab-on-grade” foundation. (See photo 1) The residence is approximately 30 years old.

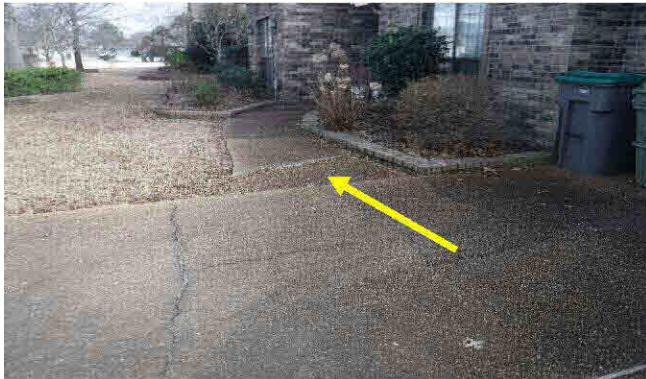
Photo 2

1. There are large cracks in the driveway and front sidewalk. (See photo 2)
2. A crack was observed on the right side of the garage. (See photo 3)
3. The drywall has cracked across the middle of the garage. (See photos 4 and 5)
4. Cracks were observed in the brick veneer on the left/front corner of the residence. (See photos 6 and 7)
5. There are cracks around the front door. (See photo 8)
6. We observed numerous cracks in the drywall and several of the door frames have shifted causing the doors to bind on the frames. (See photos 9-16)

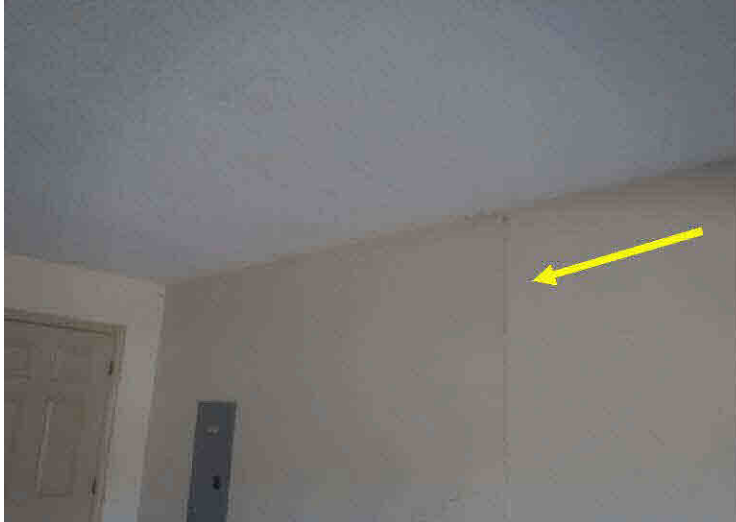
Photo 4

The exterior brick veneer cracks and interior drywall cracks were a result of the foundation settlement.

We recommend installing a total of (15) interior and (4) exterior 8" segmental block piers, located at the indicated positions in the attached sketch. Each exterior pier must be able to support a 5,000 lb. point load and the interior piers a 2,000 lb. point load. The foundation should be raised a maximum of 3/4" or just enough to transfer load to the new piers.

After installation of the piers, we recommend at least a 30-day waiting period before any drywall or other cosmetic repairs are attempted.
